Manhole Inspection Summary

Manhole # S17II_007MH

Location Address: **2300 NORTH AVE**

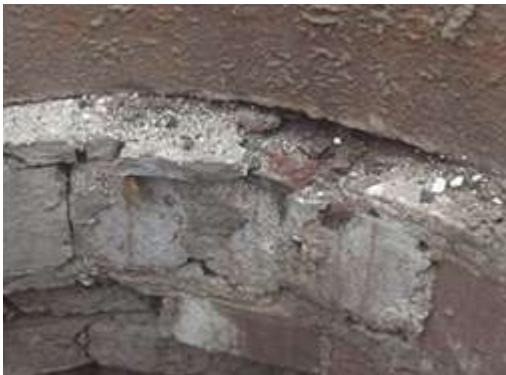
Defect 4

Condition: ☐ Sound ☐ Cracked ☐ Root Intrusion ☐ Loose Brick ☒ **Deteriorated**

DETERIORATION OF CHIMNEY

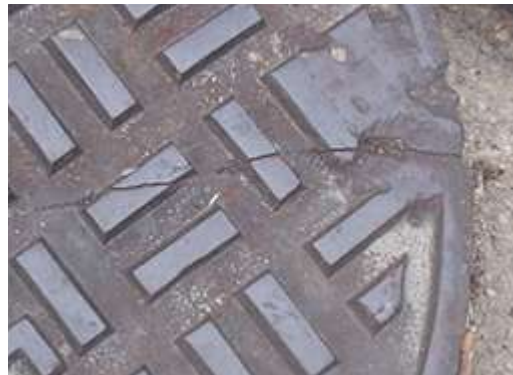
Defect 3

Type: **Sanitary** Condition: **Cracked** Cover Material: **Cast Iron**

CRACKED LID

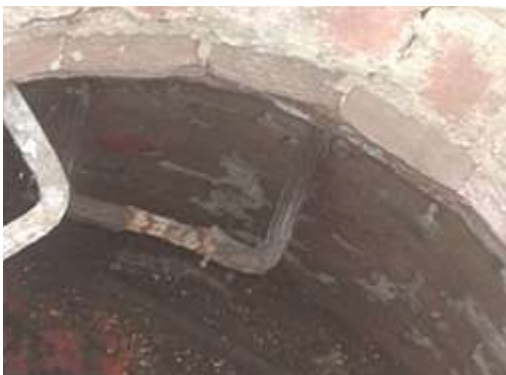
Defect 2

Steps Count: **2** Missing: **0** ☒ **Corroded**

CORRODED STEP

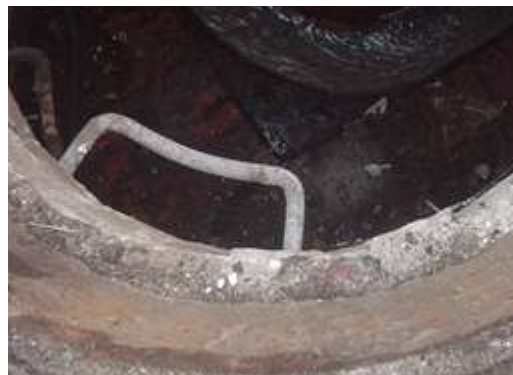
Defect 1

Frame Offset: **1** (in.) Condition: ☒ Sound ☐ Cracked ☐ Leaks

FRAME OFFSET

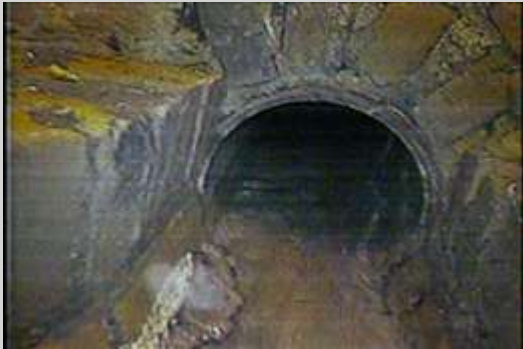
12 O'Clock Outflow

8 in. Circular Gravity Sewer
Pipe Out @ 12 O'Clock

Pipe Height: **8.4** (in.) Rod and Bar (Angled)
Pipe Material: **Clay** ☐ Pipe Lined
Invert Depth: **5.94** (ft.) Flow Characteristics: **Fast**
Deposits: ☒ None ☐ Mud ☐ Sludge ☐ Debris ☐ Grease
Silt Depth: (in.) Deposits Extent:
Infiltration: **None** Pipe Seal Cond: **Sound**

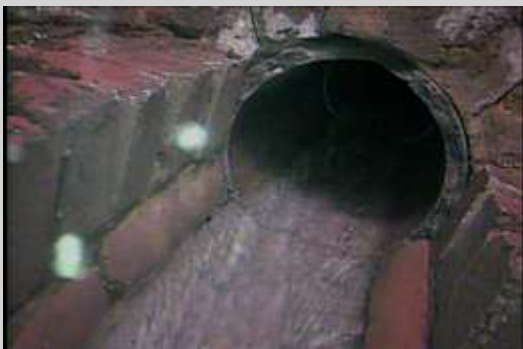
9 O'Clock Inflow

8 in. Circular Gravity Sewer
Pipe In @ 9 O'Clock

Pipe Height: **7.2** (in.) Rod and Bar (Angled)
Pipe Material: **Clay** ☐ Pipe Lined
Invert Depth: **5.69** (ft.) Flow Characteristics: **Fast**
Deposits: ☒ None ☐ Mud ☐ Sludge ☐ Debris ☐ Grease
Silt Depth: (in.) Deposits Extent:
Infiltration: **None** Pipe Seal Cond: **Sound**
